U.S. Department of Housing and Urban Development
Office of Policy Development and Research

Assessing Housing Durability: A Pilot Study

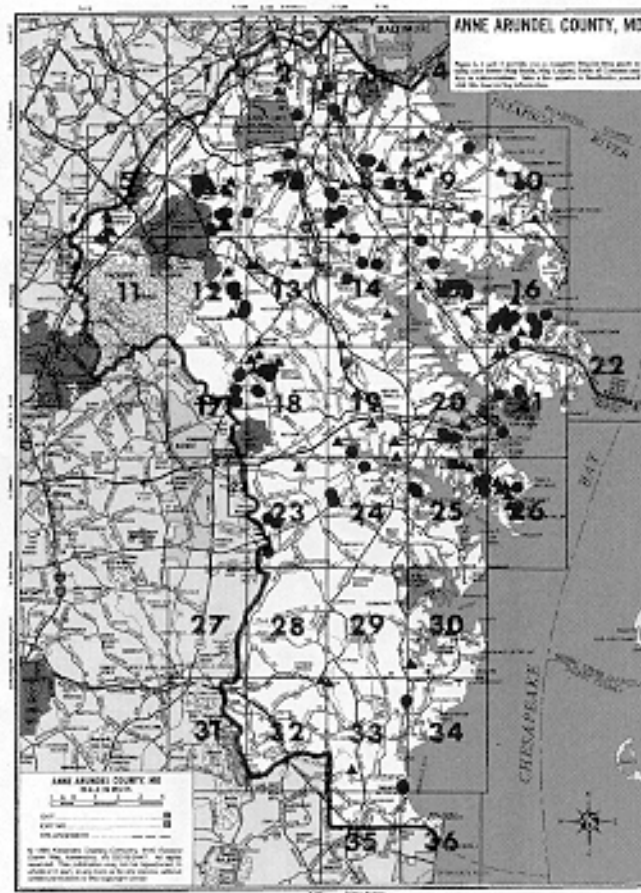
Figure 1
Study sample region.
(Anne Arundel County, MD)

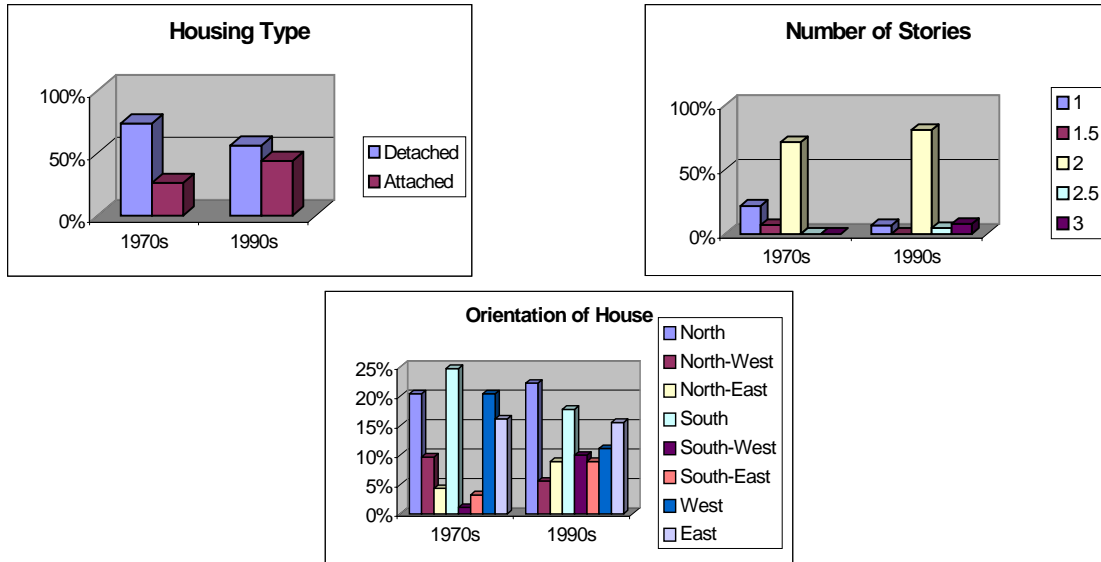
Figure 2
General sample housing characteristics.

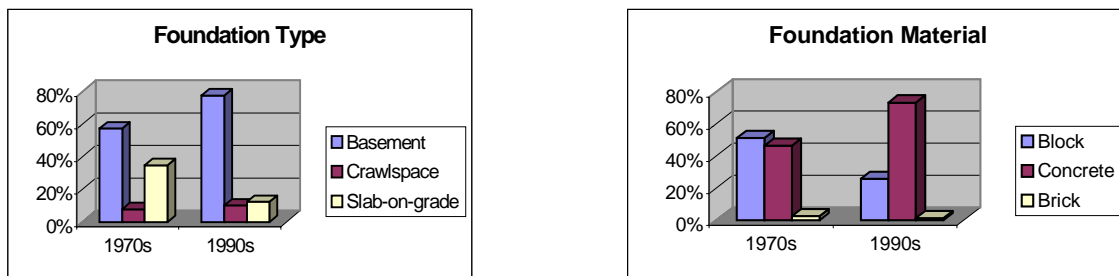
Figure 3
Foundation characteristics of sampled homes.

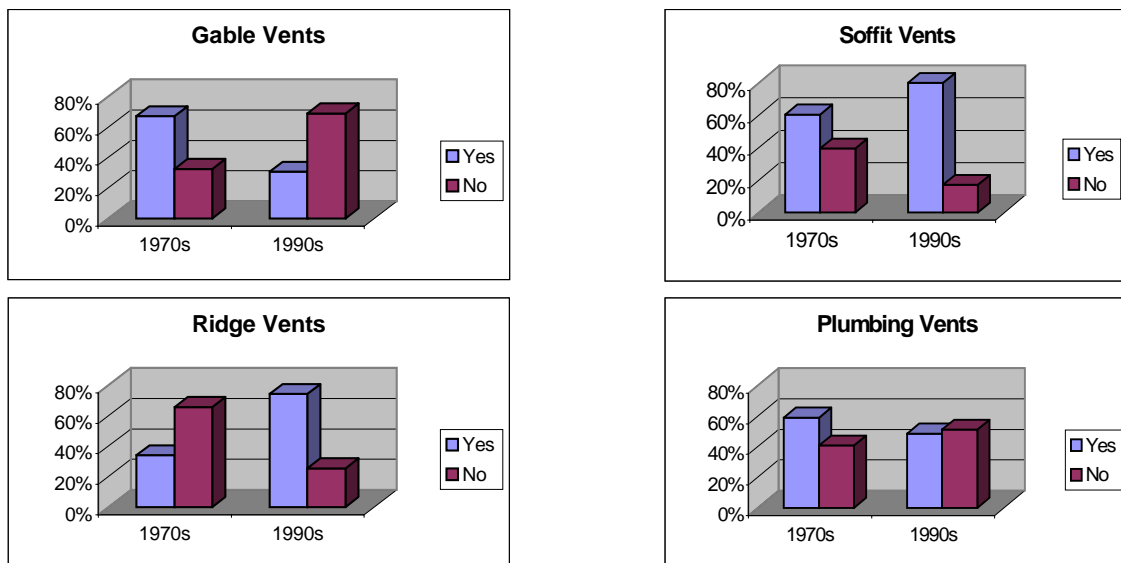
Figure 8
Roof venting and penetrations.

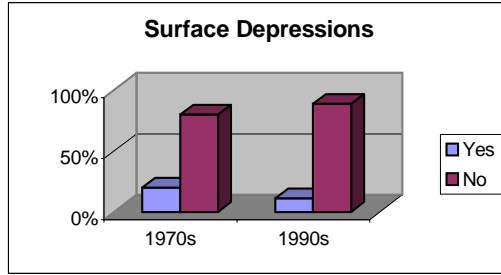
Figure 12
Frequency of surface depressions observed on sampled sites.

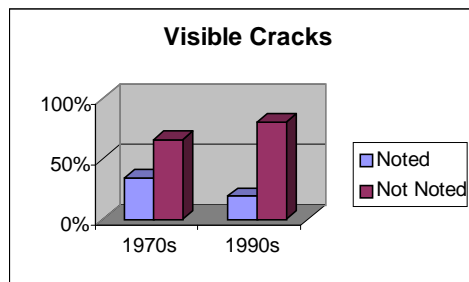
Figure 13
Frequency of observed foundation cracks on sampled homes.

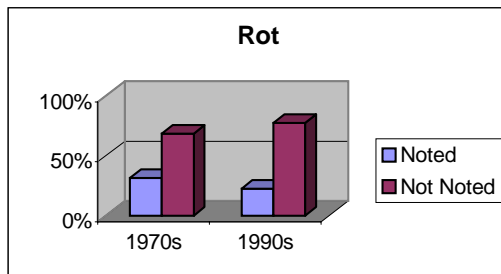
Figure 14
Frequency of observed rot in sampled homes.

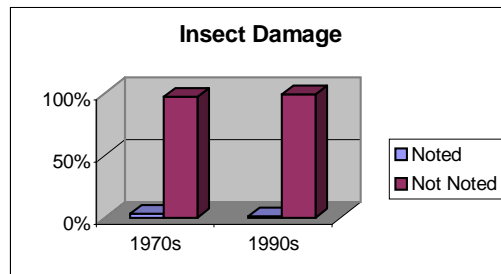
Figure 15
Frequency of observed termite damage.

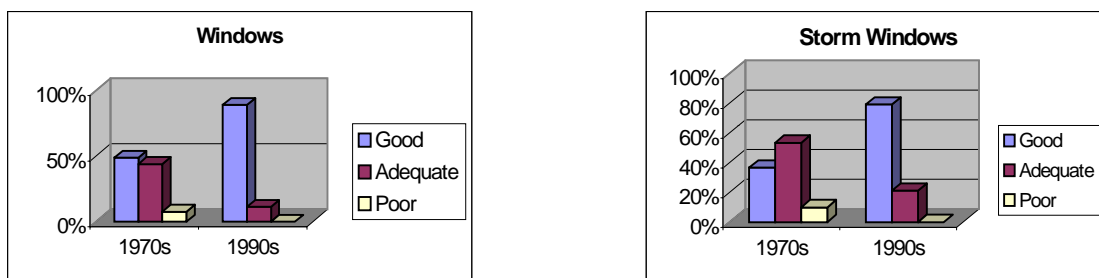
Figure 16
Window condition ratings of sampled homes.

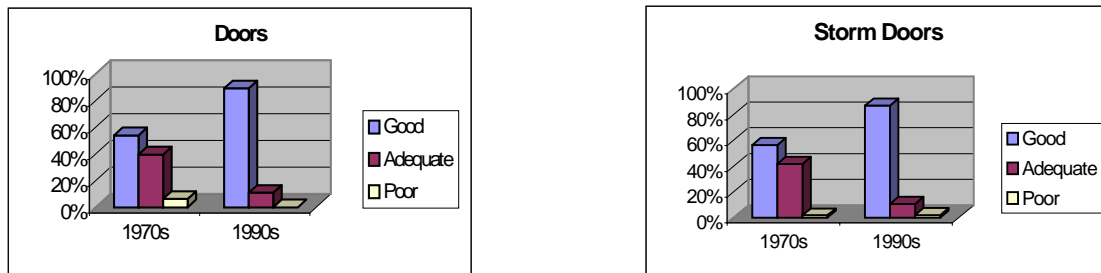
Figure 17
Door condition ratings of sampled homes.

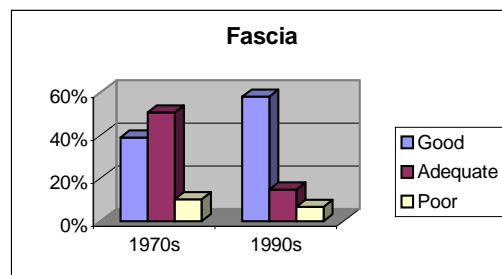
Figure 18
Fascia condition ratings.

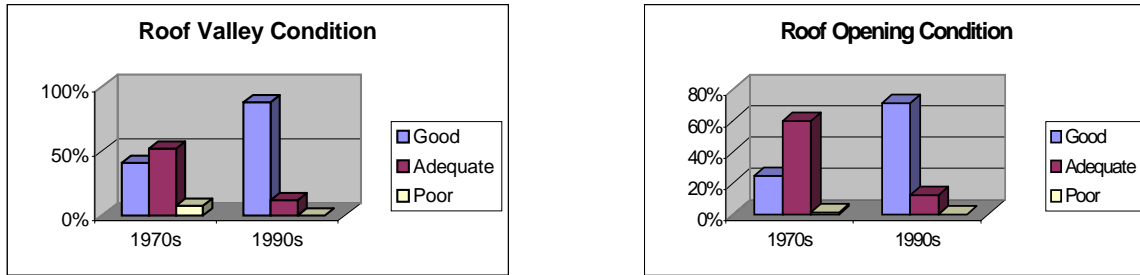
Figure 19
Condition ratings of roof features.

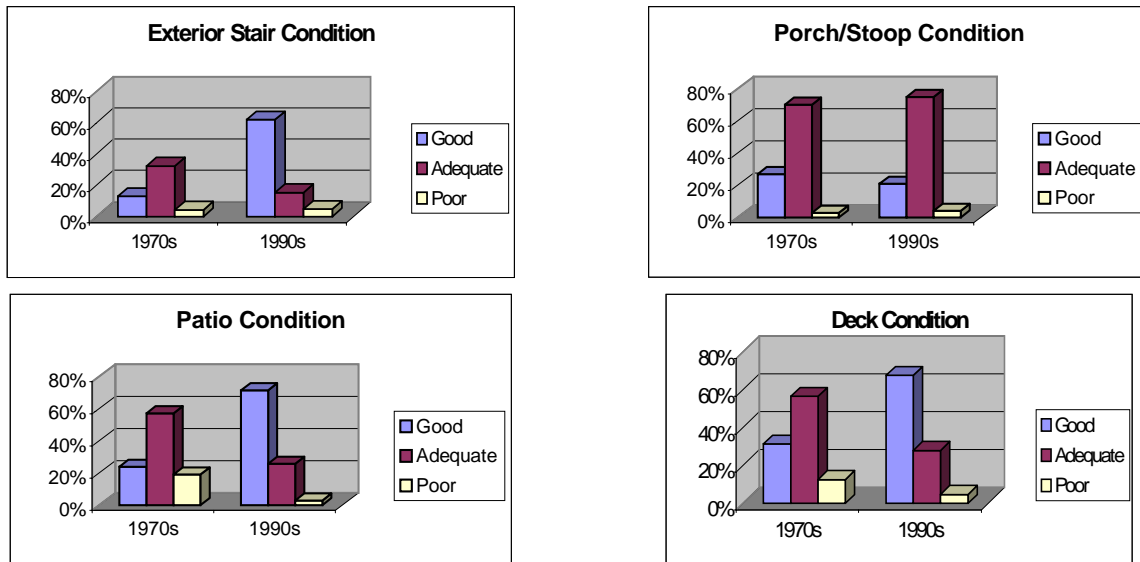
Figure 20
Ratings of exterior stair, porch, patio, and deck condition.

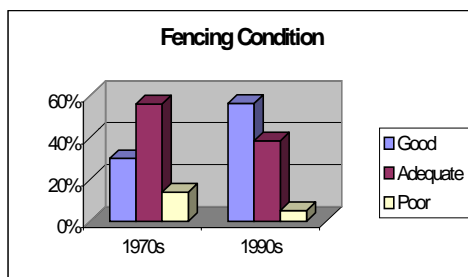
Figure 21
Rating of fencing condition.

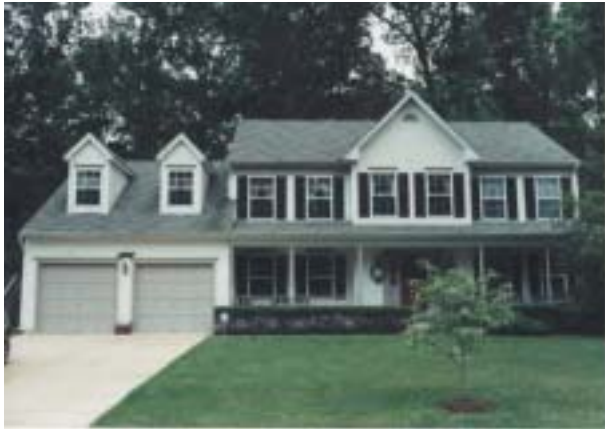
Figure 22
Example of good rating for site grade and drainage.

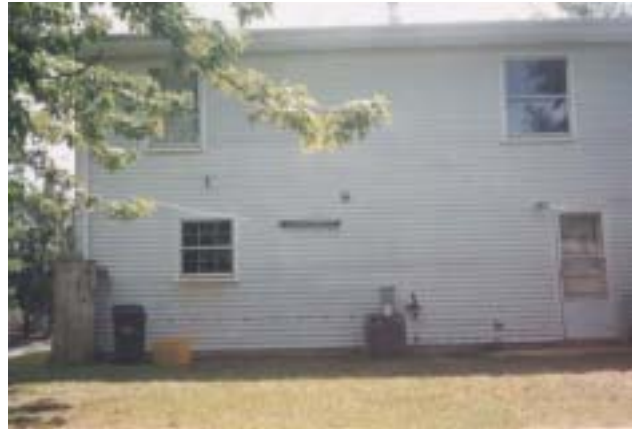
Figure 23
Example of poor rating for site grade and drainage.

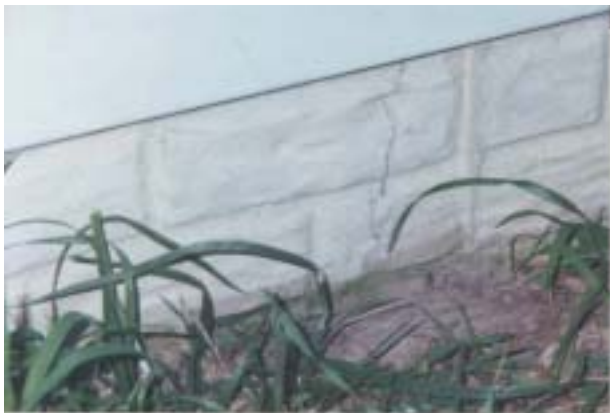
Figure 24
A typical small crack found in a concrete foundation wall.

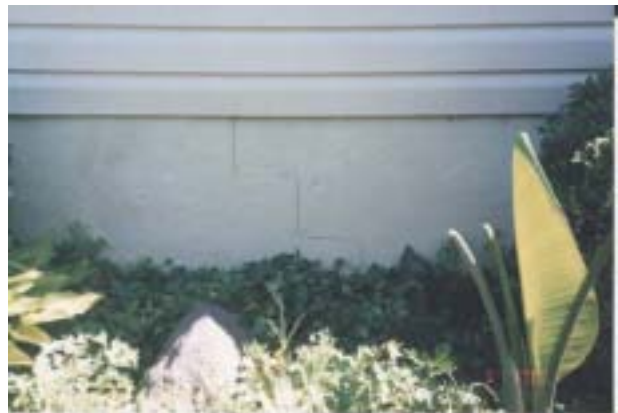
Figure 25
A typical small crack found in a masonry foundation wall.

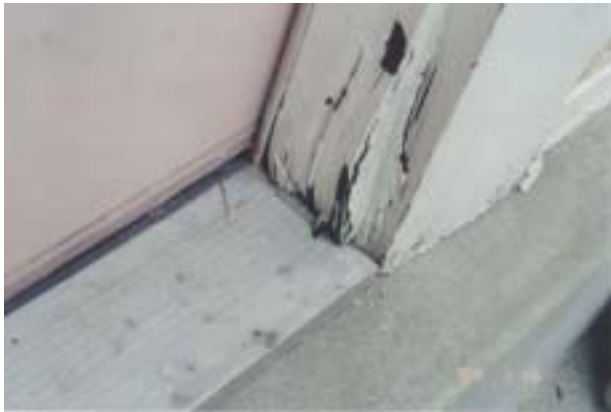
Figure 26
Rot at the bottom of a door frame in a 1990s sample house.

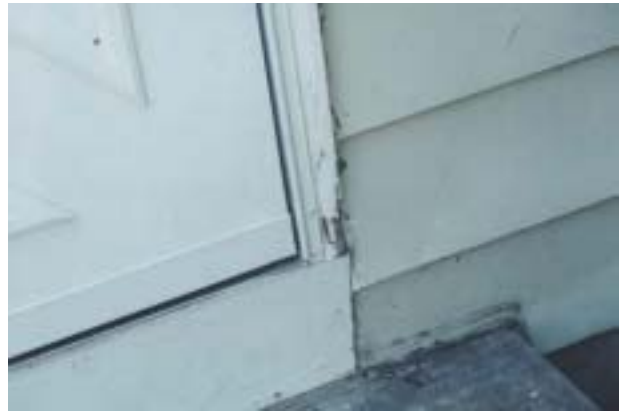
Figure 27
Rot at the bottom of a door frame and trim in a 1970s sample house.

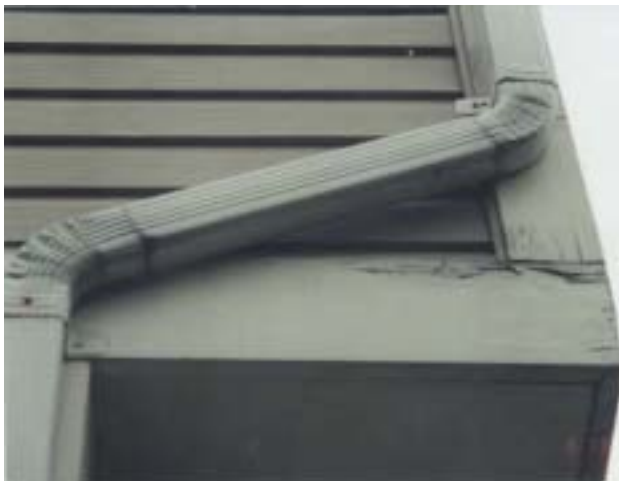
Figure 28
Rot in exterior wood trim of a 1990s sample house.

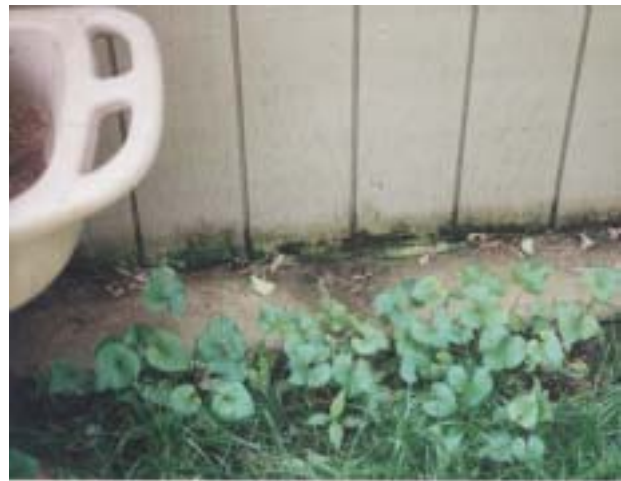
Figure 29
Rot at the bottom of wood panel siding (insufficient ground clearance) in a 1970s sample home.

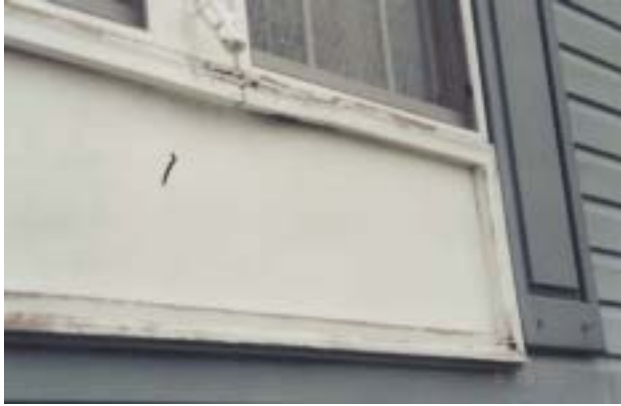
Figure 30
Rot in wood trim associated with poor detailing (i.e., lack of cap flashing) and maintenance in a 1990s sample home.

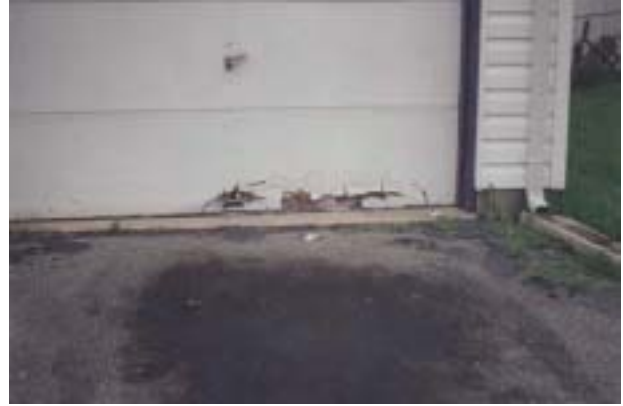
Figure 31
Rot of wood composite panel on a garage door (1970s house sample).

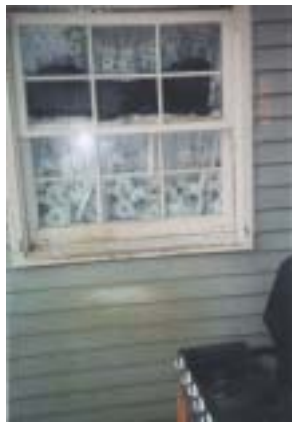
Figure 32
Abnormal wear and tear on a wood window as an apparent result of pet scratching.

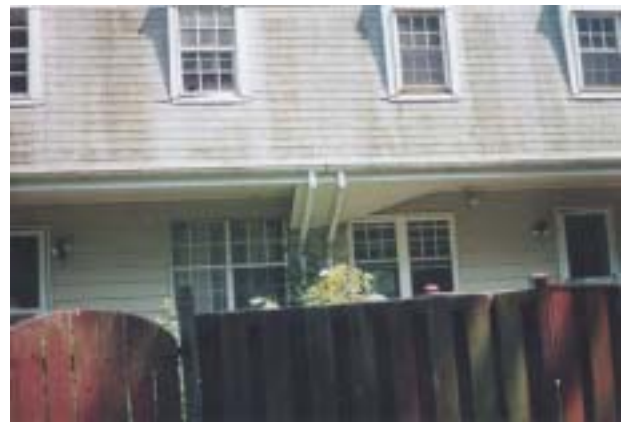
Figure 33
Broken window pane on second-story window.

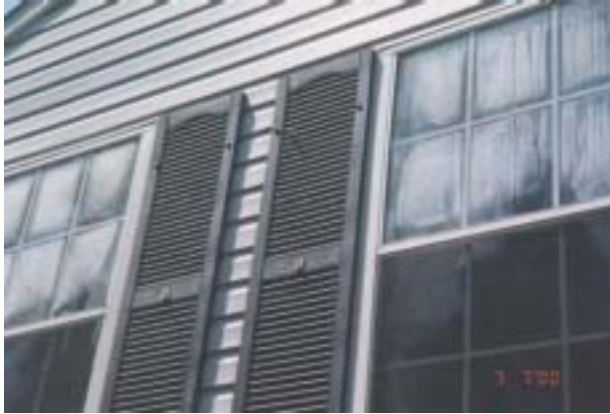
Figure 34
Condensation inside double-pane windows.

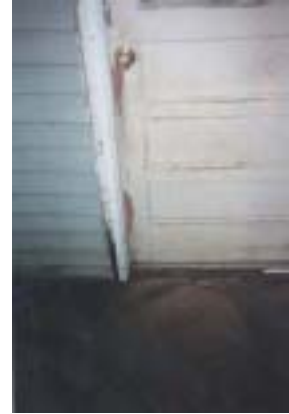
Figure 35
Abnormal wear and tear on a wood door as an apparent result of pet scratching.

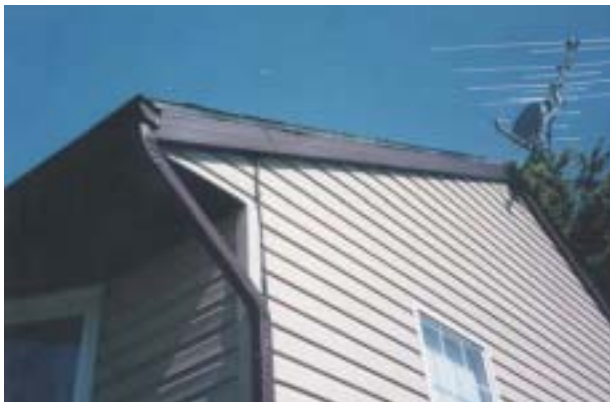
Figure 36
Example of aluminum fascia covering older fascia material on a 1970s sample house (rated good by inspector).

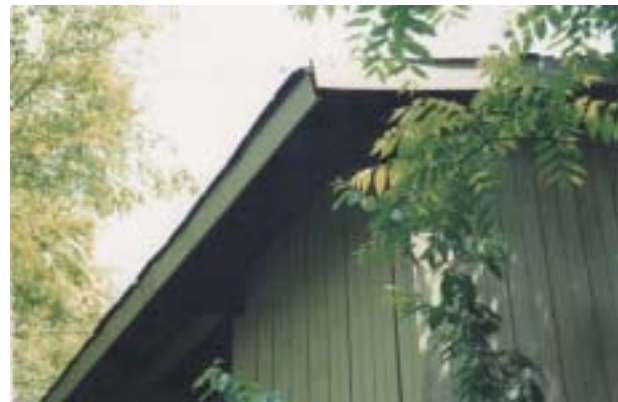
Figure 37
1970s sample house with wood fascia needing minor repair (rated adequate by inspector).

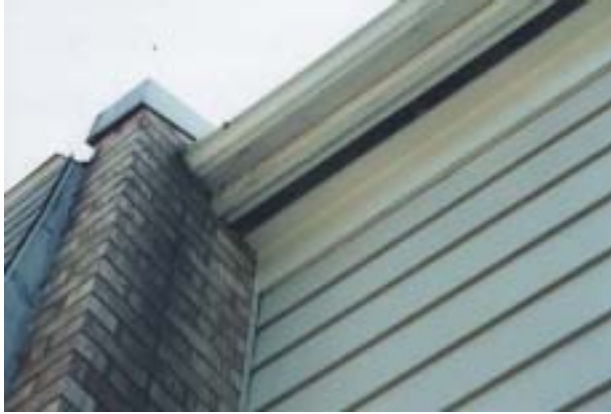
Figure 38 shows that the wood fascia of a 1970s townhouse was also subject to rot at end joints at the brick party wall. Figures 39 and 40 illustrate a failed gutter and damaged soffit for two 1970s sample homes. Other problems with gutters are shown in Figures 41 through 45.

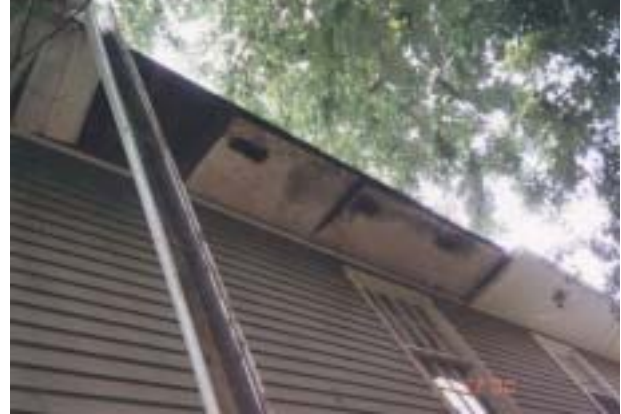
Fascia with a poor rating due to signs of rot and paint failure at butt joint to a party wall on a 1970s townhouse sample.

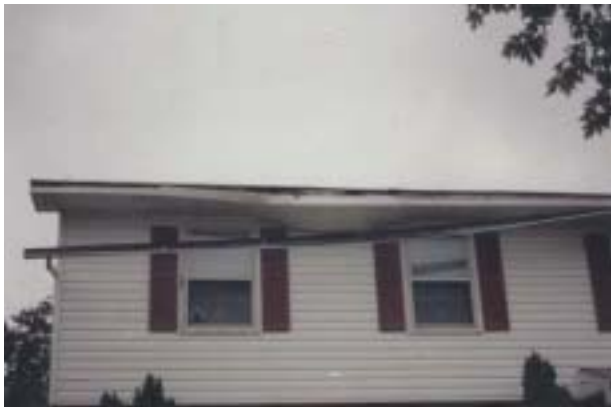
Failed gutter and signs of water damage to soffit on a 1970s duplex house sample.

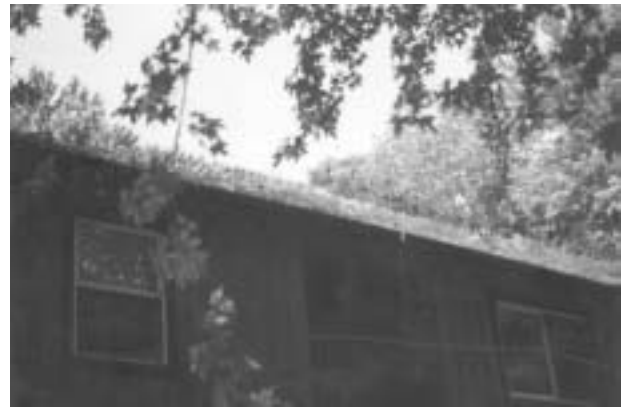
Failed guttering and signs of water damage on wood fascia underneath aluminum fascia cover (1970s house sample). Note paint failure on window frames.

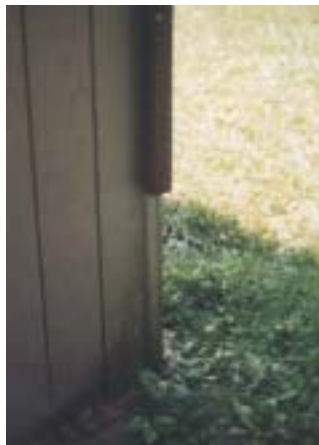
Vegetation growing in poorly maintained gutter.

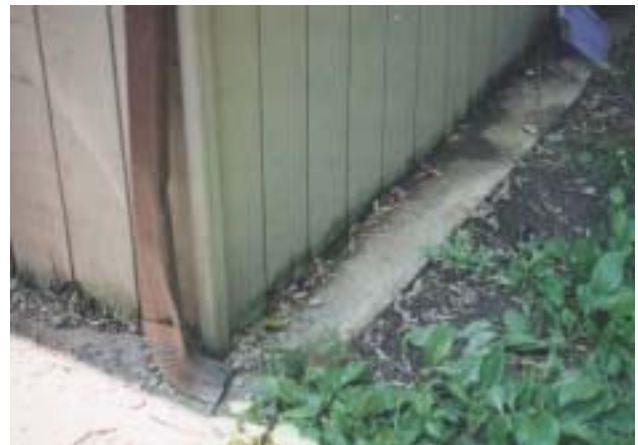
Failure to maintain outfall of gutter downspout. Note that wood panel siding does not have sufficient ground clearance.

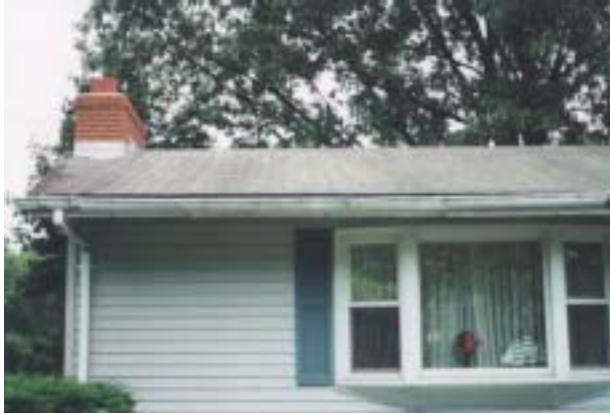
Figure 44
Sagging gutter.

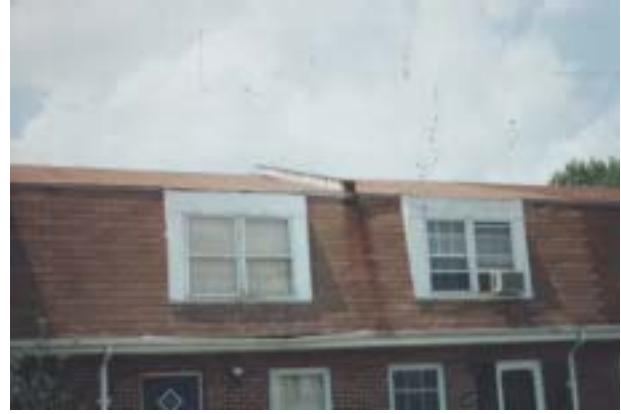
Figure 45
Rusting party wall cap flashing and damaged gutters.

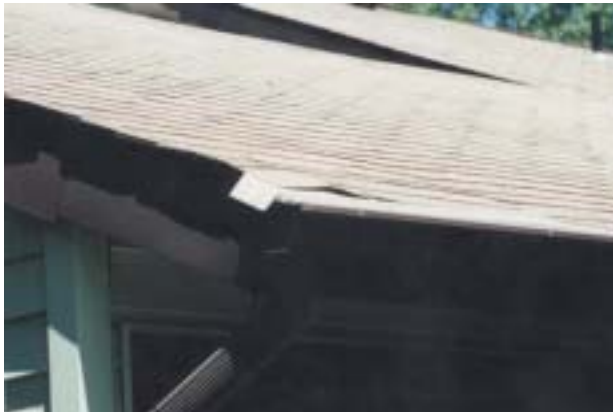
Figure 46
Example of a 1970s house sample with roofing rated as adequate.

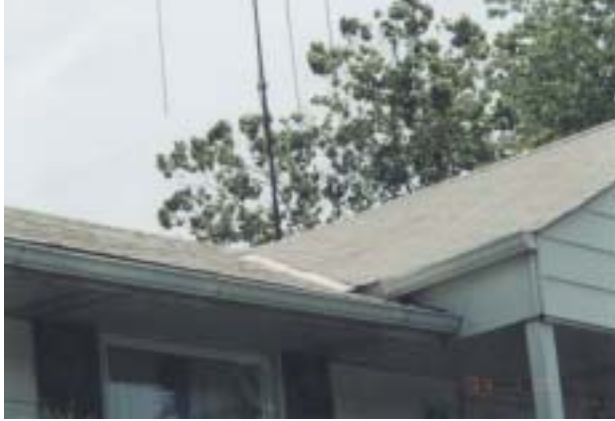
Figure 47
Example of a 1990s house sample with roofing rated as adequate.

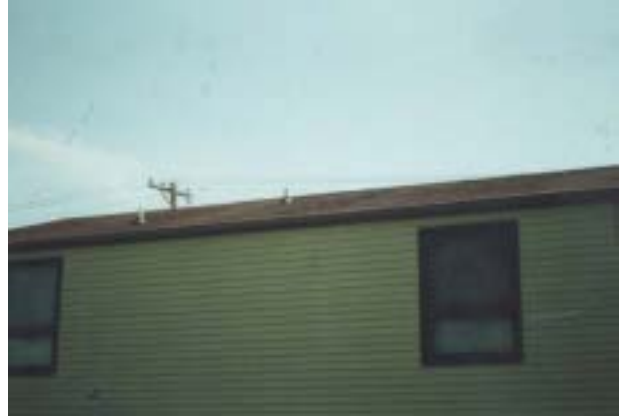
A 1970s house with a poor roof based on improper valley flashing and curled shingle tabs on the left roof surface.

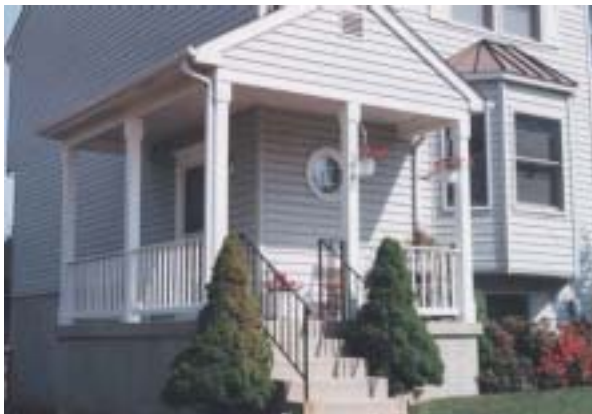
This section addresses porches, decks, and sidewalks. Figures 50 and 51 show the porches of two 1990s and 1970s sampled homes that were rated as good. In each case, the porch floor was concrete and wood, where used, was adequately protected from weather and moisture. However, wood deterioration was evident on the porches of the 1970s and 1990s house samples as shown in Figures 52 and 53, respectively.

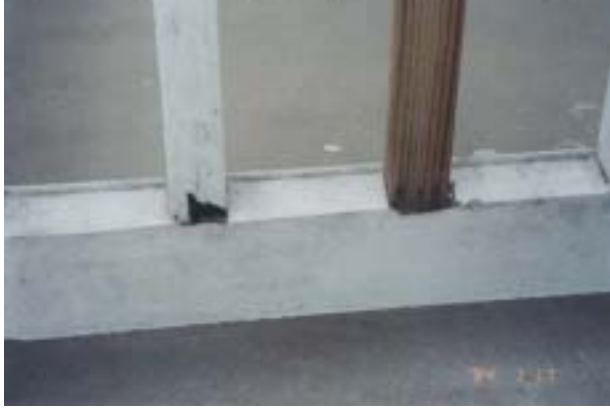
Porch with good rating (1970s house sample).

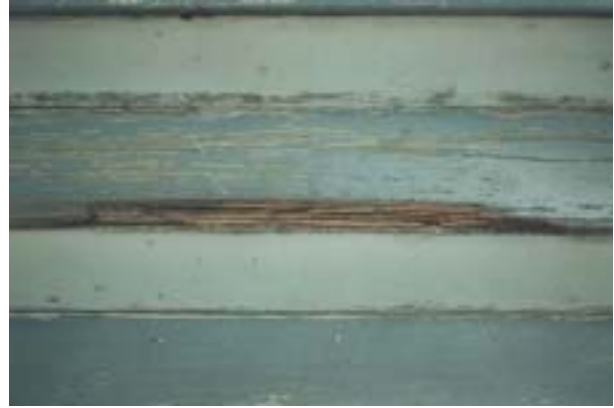
Rot in a wood picket on the porch of a 1970s sample home (one picket has been replaced with treated wood).

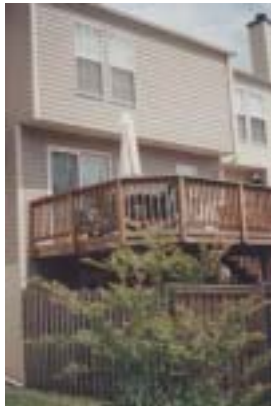
Figures 54 and 55 show typical decks with a good rating. Unfortunately, the photographic record does not include usable pictures of decks in poor condition for purposes of contrast.

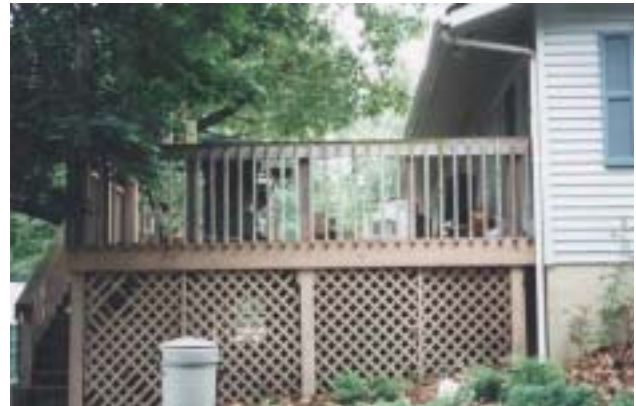
Example of a wood deck in good condition (1990s house sample).

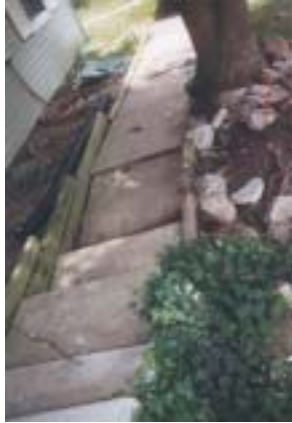
Figure 56 shows an example of a sidewalk in poor condition for a 1970s sample home. Uplift of the sidewalk was caused by growth of a tree planted too close to the sidewalk. In Figure 57, ponding of water on a sidewalk adjacent to a 1990s house sample is apparent immediately following rain. The downspout and splash block discharge to the sidewalk surface.

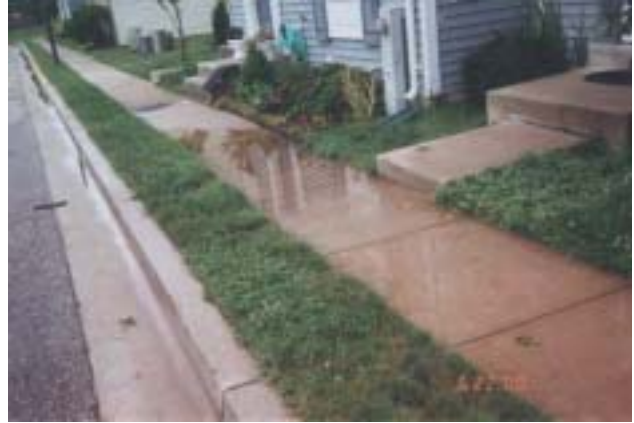
Sidewalk of a 1970s sample house in poor condition due to root movement and growth of a closely located tree.
